Flow

TR-1096

HyPlex Visual Inspection Guide

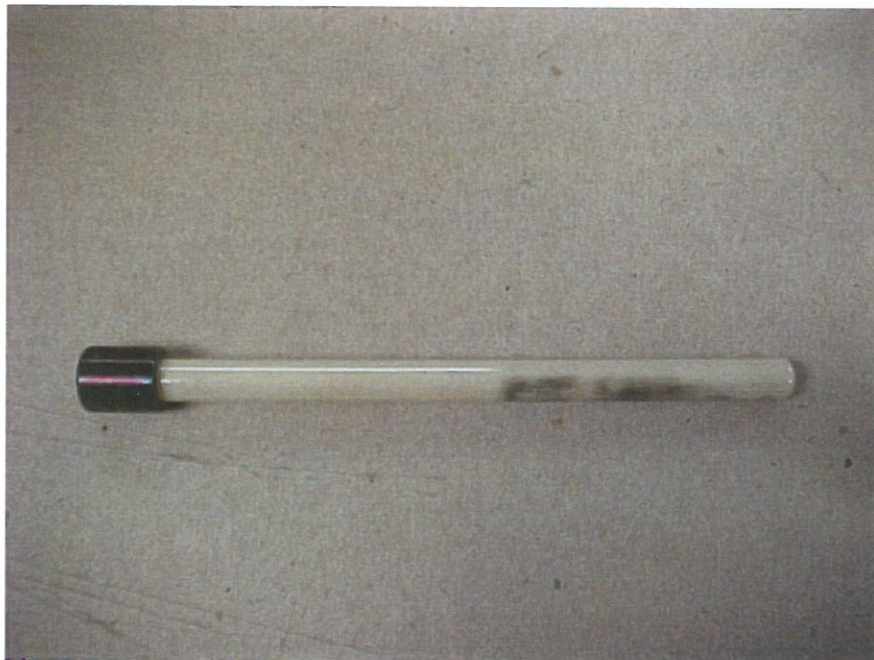
Figure 1

Plunger damage: contact with dynamic seal carrier

Damage seen on this plunger is typical to that seen on a plunger that has been allowed to run through the failure of a dynamic seal. Often one side will show heavy black marks. Any variation of marking in this area that can not be removed by wiping with a rag requires replacing the plunger or risk an early seal failure after the following maintenance.

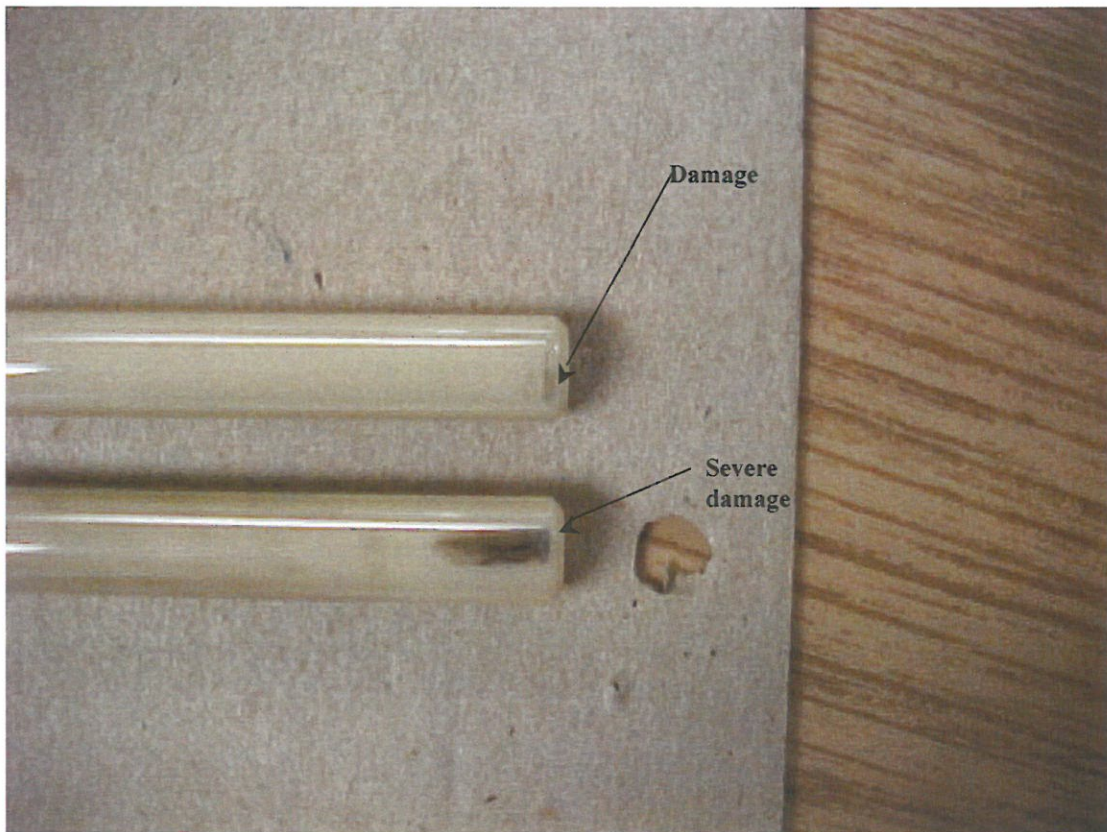
Figure 2

Plunger damage: misalignment

The plunger on the top has seen minor contact with the inlet spring. A close inspection of the inlet spring reveals that the last loop of the spring nearest the poppet is shiny. This will contribute to lower than normal seal life. The cause of this contact is most likely misalignment. The life of the inlet spring is not known to be affected even after contact with the plunger.

The plunger on the bottom has seen sever contact do to misalignment. In this case, the misalignment would be expected to be even more extreme. Plunger replacement is required in both examples shown in the photos below.

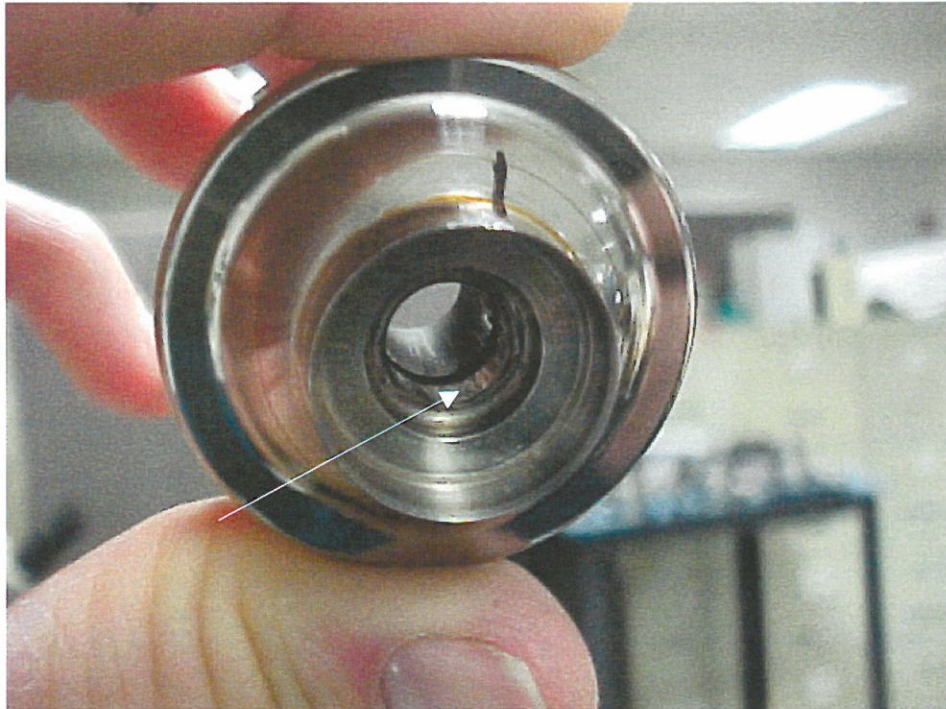
Figure 3

The dynamic seal carrier is one of the most critical parts in assuring proper pump performance. If the dynamic seal fails, damage often occurs to the carrier. Two types of damage can occur. One type is contact between the plunger and carrier and the other type is erosion caused by dynamic seal leakage. The evidence of plunger contact is noticed easiest by looking at the plunger as was discussed in the previous section. Holding the carrier up to a light source so that the surface can be viewed has also been found to be useful in identifying plunger contact. If plunger contact exists, then the carrier must be replaced. Axial scratches on the inner diameter (shown below) of the carrier are indications of contact with the plunger.

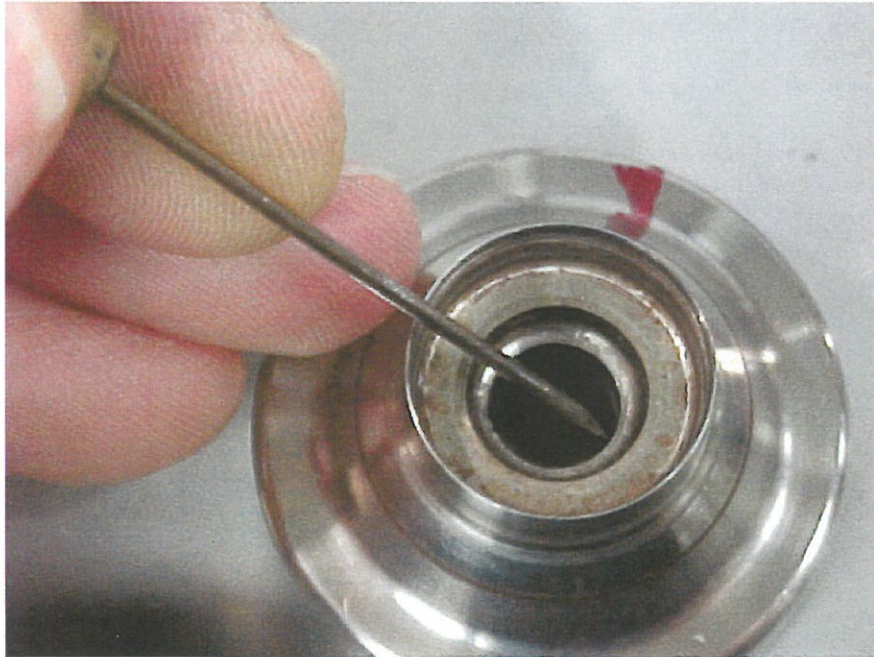
Figure 4

Identifying damage to the edge, shown in the below photo, is critical to ensuring proper performance of the next seal that will be used with this carrier. The most effective means for detecting this damage is by visually inspecting the carrier with magnification. This is often not available and therefore other methods must be employed to detect minor damage to the edge. One method employed is to mark the entire edge with a marking pen, like the "sharpie" brand. The ink will penetrate into the minor erosion damaged locations. Next, the surface is wiped clean. Only the machined surfaces get wiped clean and the erosion marks are highlighted by the remaining ink. Magnifying the surface enhances this method further. Minor erosion marks, even those barely visible with the naked eye will adversely affect the performance of the seal. If erosion marks are present, then the carrier should be replaced.

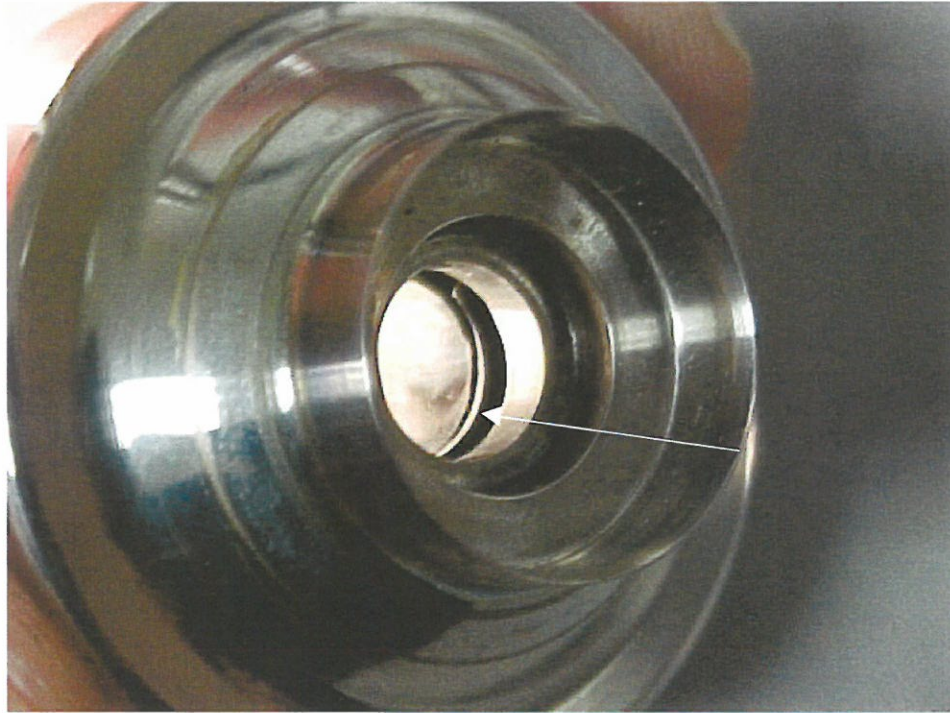
Figure 5

Inspecting the carrier to insure loose bearing material does not exist should be conducted. The below photo shows an example of this damage. If a broken piece of bearing becomes dislocated the likely result is a premature dynamic seal failure

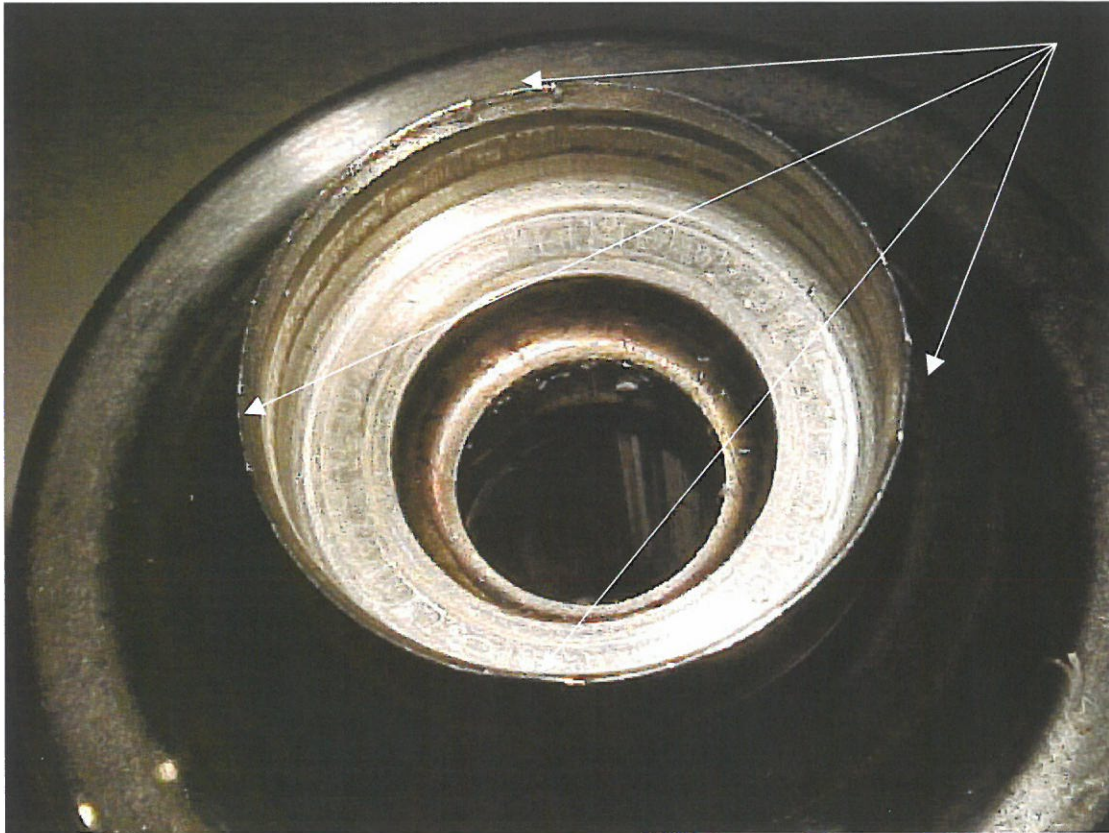
Figure 6

Damage can also be observed on the carrier if the inlet poppet is pinched during assembly. The result of this assembly error can be seen as imprints on the thin lip that extends out from the static sealing face. The photo below shows the four imprints from the filler tube. Often this end is bell-mouthed as well. The carrier can be reused if this damage is noticed, but other items like the filler tube sleeve and the inlet poppet should be inspected.

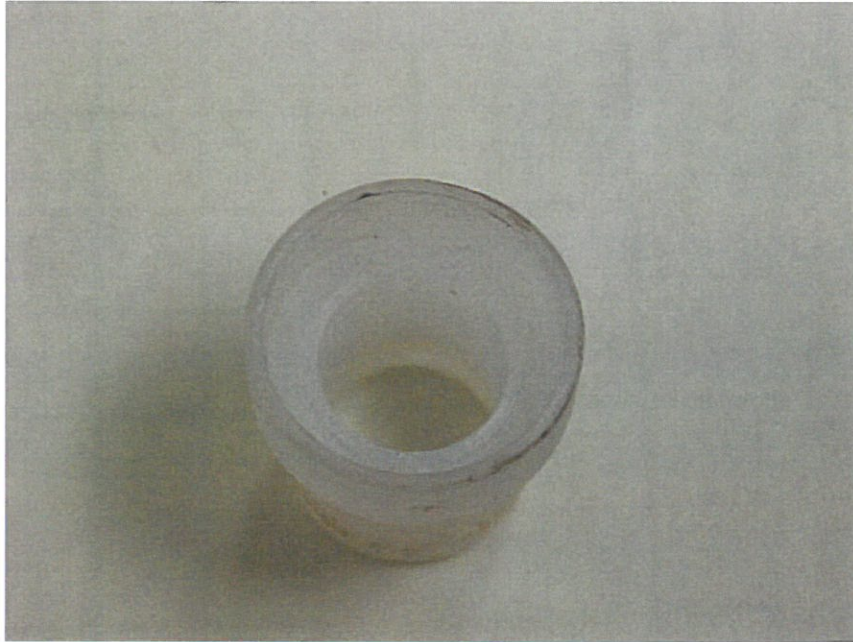
Figure 7

The above photo shows a typical seal after some run time. The greatest wear in the seal should be apparent at the (as shown) lower end, inside diameter of this seal. This photo is not detailed enough to illustrate the wear.

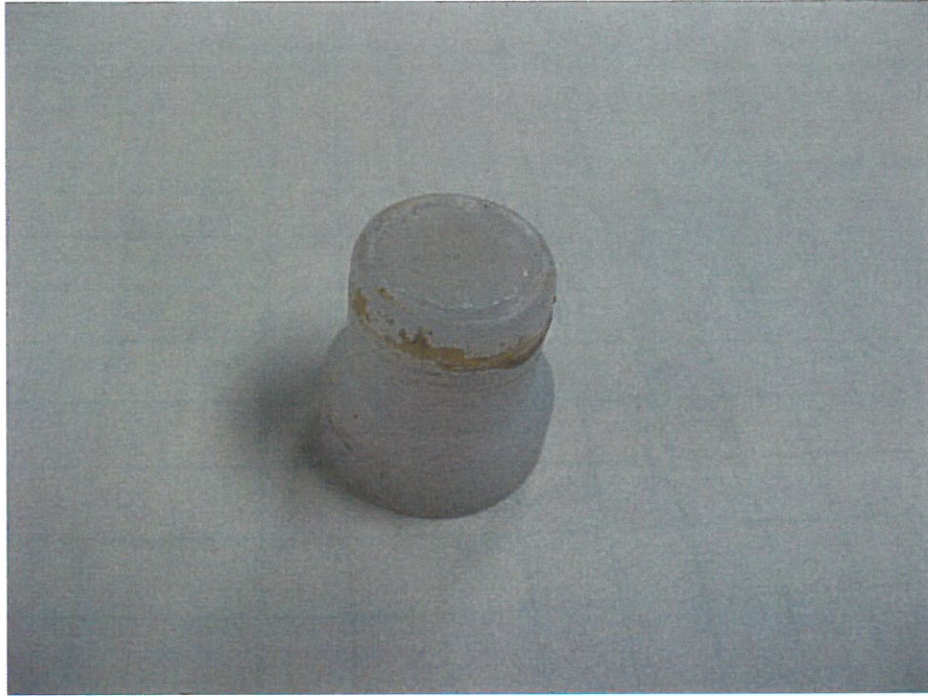
Figure 8

Above is another typical view of a used seal. This seal does not show evidence that it was failed since the end, shown here as the top, remains very uniform. The darker material attached to the outside of the seal is a combination seal material and u-cup material. It is typical to see this buildup.

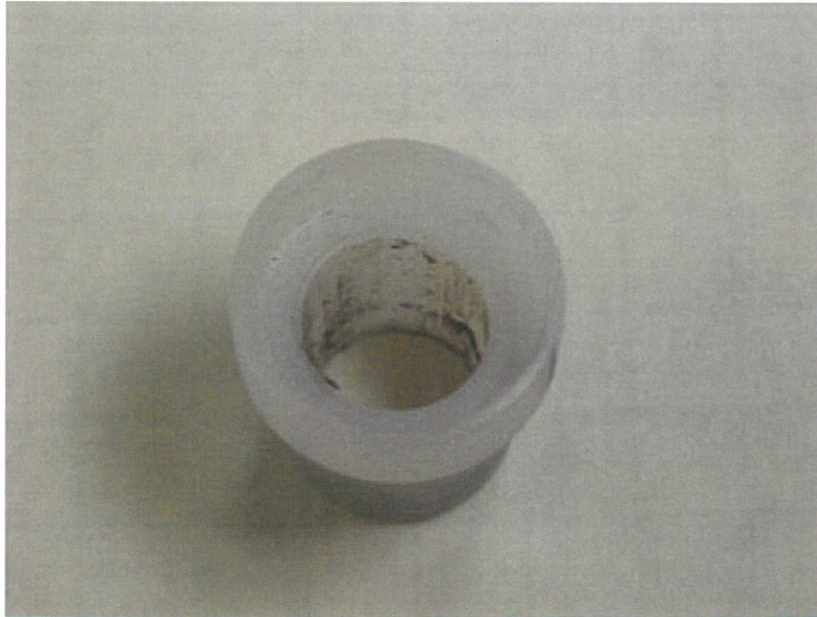
Figure 9

The above seal experienced plunger/carrier contact and damage to the bearing. Numerous observations from the field indicate that dark material on the inside of the seal is common. The current stance of engineering, regarding this observation is the following: Don't replace a seal that has a dark material in its bore just because it is dark. In troubleshooting an early failure of a seal, observing the id color along with other features of the plunger and seal carrier may be useful in determining the mode of failure.

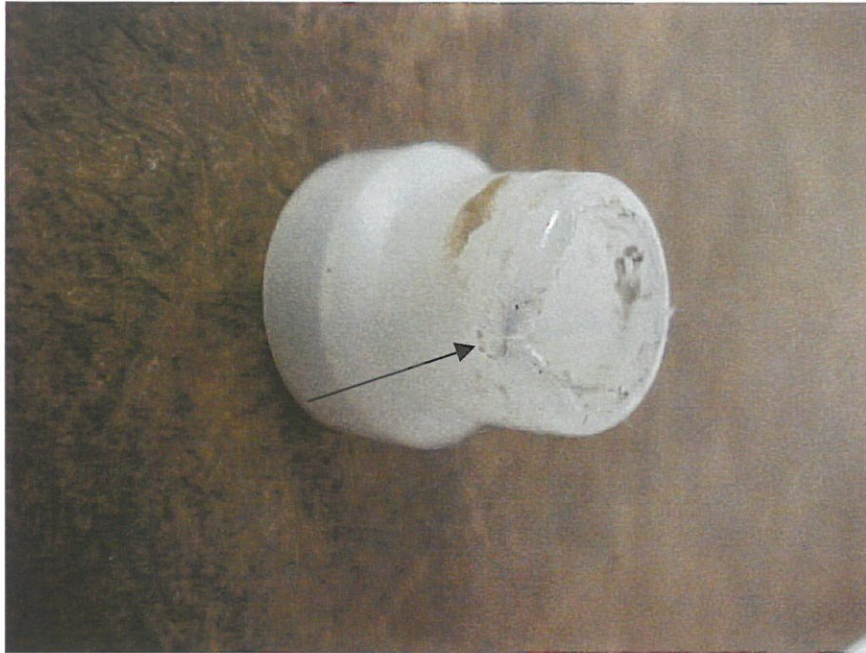
Figure 10

The above seal failed. The feature that best identifies a failed seal is appearance of a region that has lost more material than other locations. This location is commonly called a “mouth”(arrow) or “v-notch”. The “mouth” or “v-notch” is the location where leakage occurred.

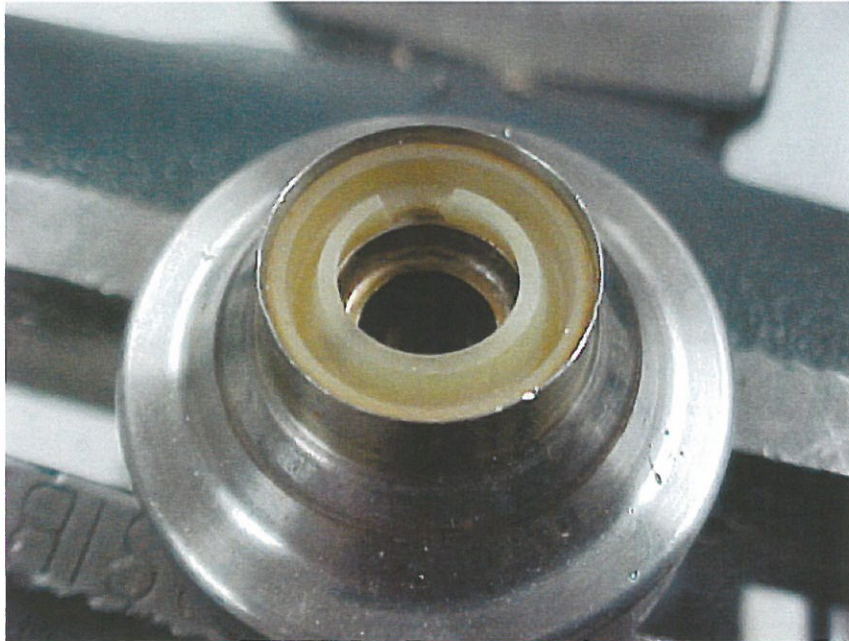
Figure 11

When a dynamic seal is allowed to run until failure, the u-cup seal is often damaged adjacent to the failure of the dynamic seal. The typical damage to the u-cup is seen below.

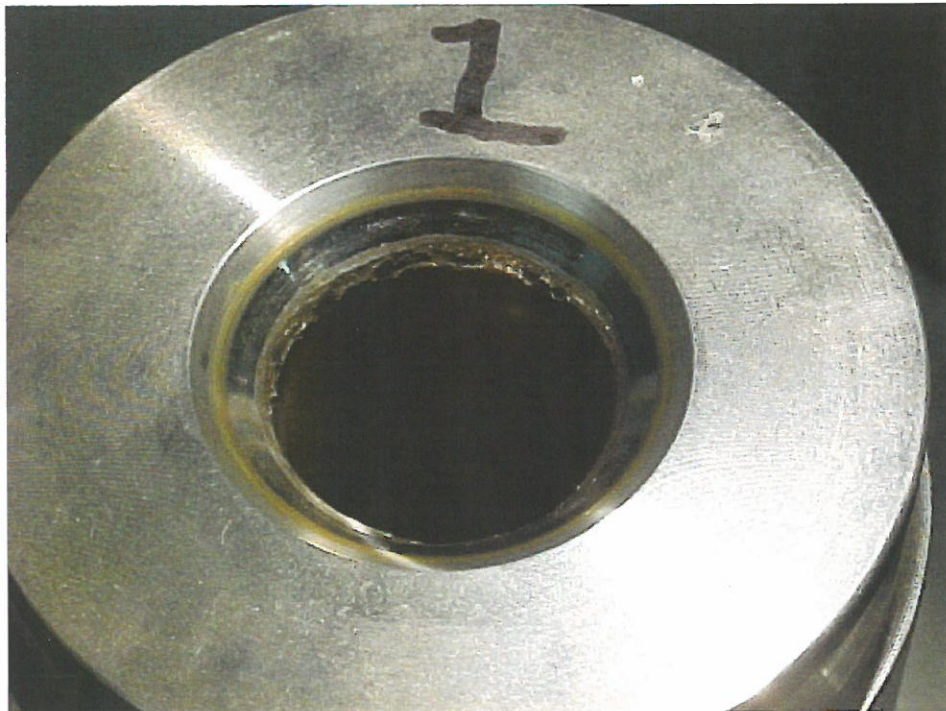
Figure 12

The edge that transitions the bore of the cylinder into the sealing face of the cylinder is susceptible to deterioration from fretting. The surface upon which sealing occurs will have a shiny appearance. The condition that causes the failure in this manner is similar to fatigue. The contact stress between the cylinder and the checkvalve body or the dynamic seal carrier changes with every stroke. After many cycles the material will begin to exhibit the appearance that small sections of the material intend to separate from the surface. This is some times referred to as "spalling". If allowed to continue the material loss will be sufficient to render the contact surface useless. Some amount of deterioration is normal through the life of the parts. If damage at the static sealing surface is sufficient to require replacement of the cylinder, checkvalve body or carrier, it is recommended to replace all mating components at that time. This strategy is consistent with the part replacement conducted in the major maintenance kit. It is not usual for this damage to appear early in the life of the component.

The damage shown in the photo below is in the advanced stage but, the sealing surface is still in tact; therefore we would expect this part will seal up if re-installed. All cylinders will eventually become damaged like the one shown below. Replacing them at the first sign of this damage is not recommended because this will result in high operating cost. If it re-seals the cylinder would be considered "good". The likely downside of reinstalling a cylinder with this advanced level of damage is that the debris will cause checkvalve damage. The debris may also travel to the nozzle. Customers using small orifices may experience nozzle plugging or damage under this circumstance. If damage like this is seen on parts with less than 1000hrs then, lower than normal tie rod load (not necessarily torque) may be the cause.

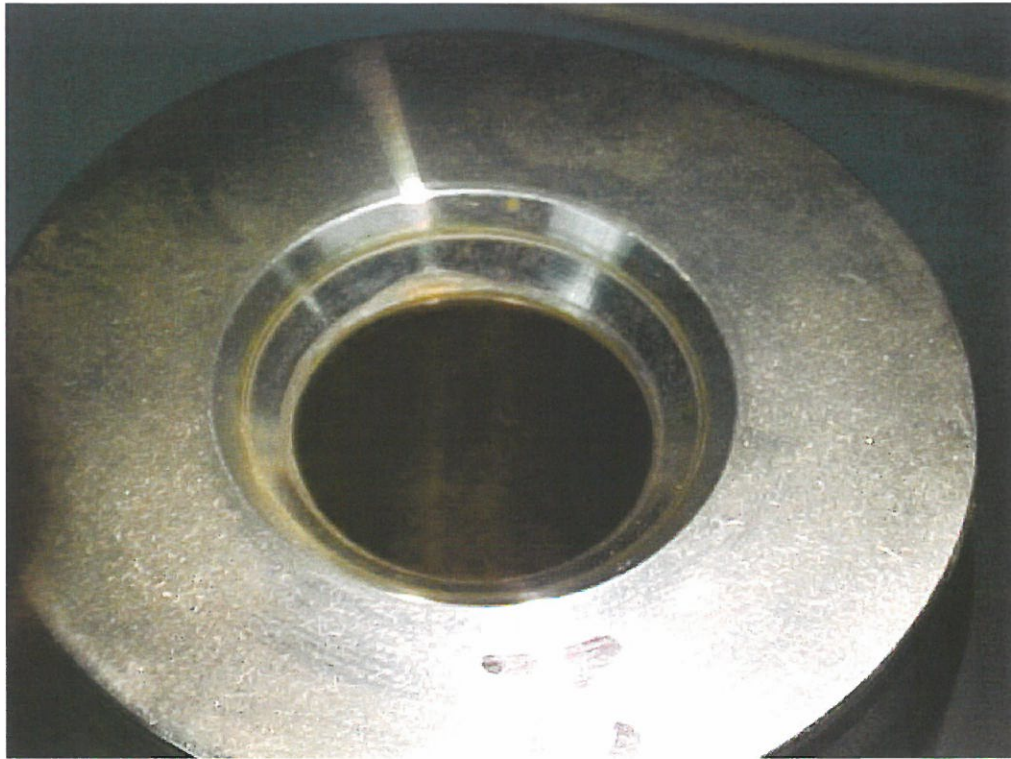
Figure 13

The photo shown below is a typical surface with slight evidence of material deterioration moving into the sealing surface. This part would be reused.

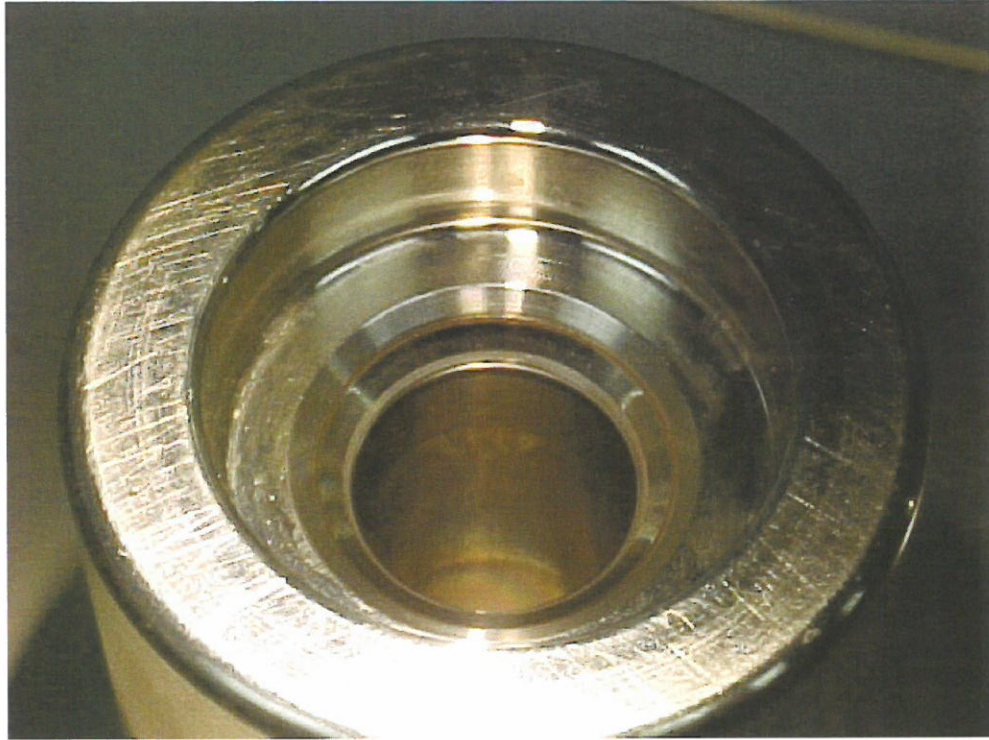
Figure 14

The below photo shows the typical look of the dynamic seal carrier end of the cylinder. We expect that fretting damage can happen here as well as the checkvalve end of the cylinder.

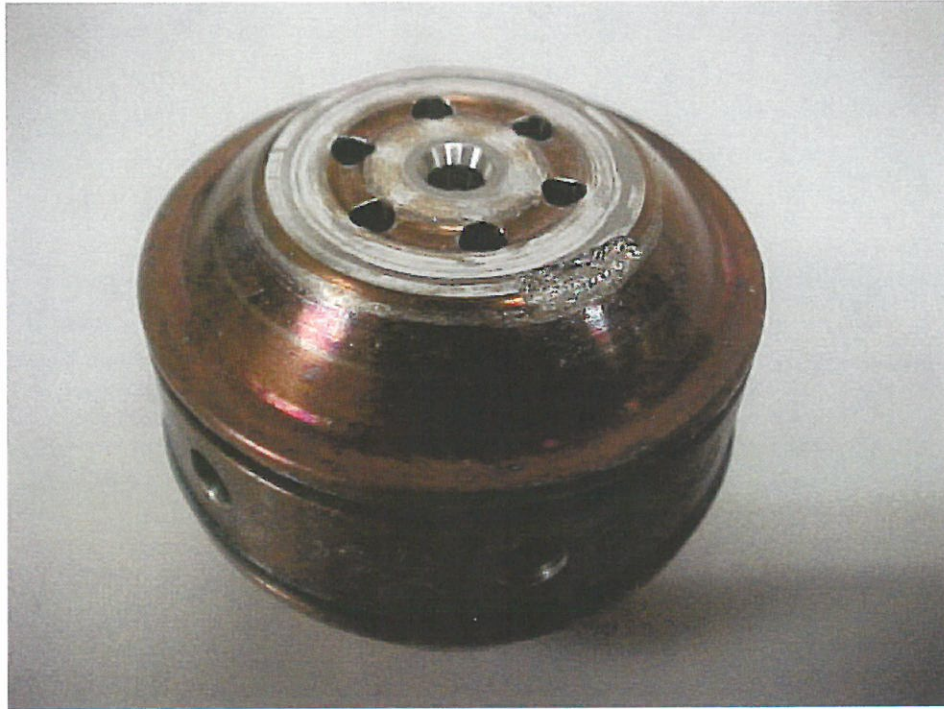
Figure 15

Fretting damage can affect the checkvalve body as well. The photo below shows the spall of material lost from what started as fretting damage. This body must be replaced.

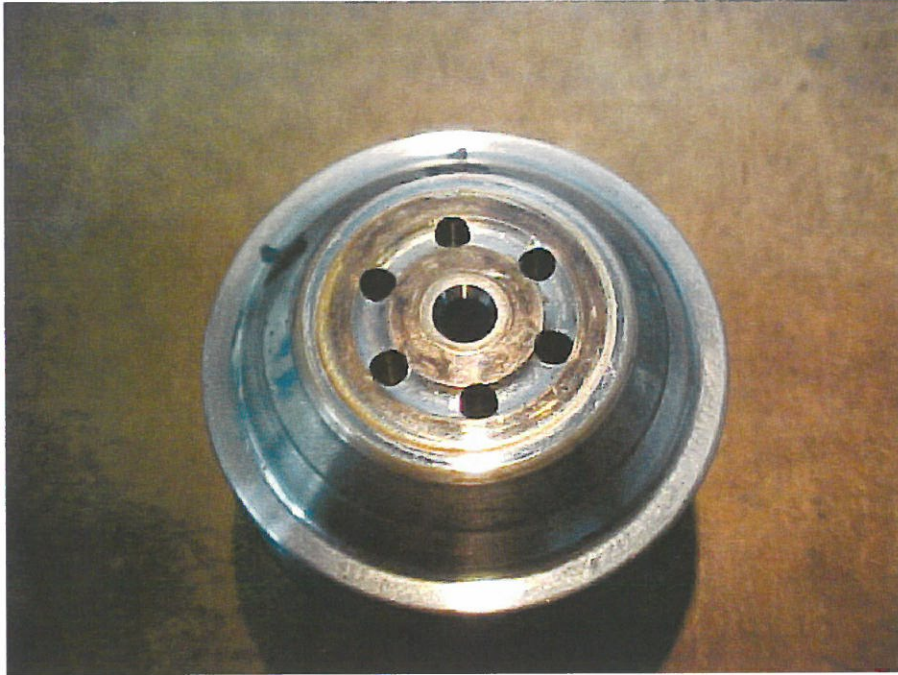
Figure 16

Typical inlet check surface at 500hrs/50hp HyPlex. This face should be lapped as described in the maintenance procedure prior to reuse.

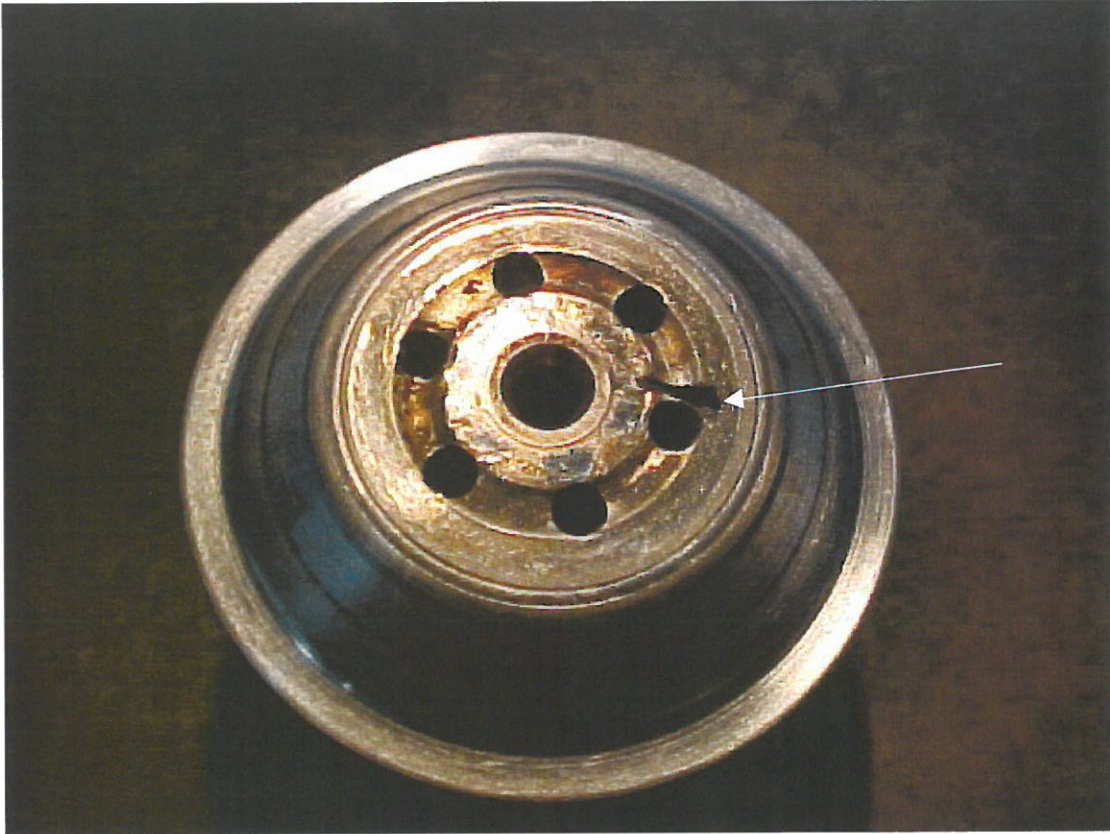
Figure 17

This inlet checkvalve body face surface shows an erosion path. This erosion track is too deep to be lapped out and the body will need to be replaced. Erosion damage like this may have been caused by a piece of debris that became stuck between the inlet poppet and the body face.

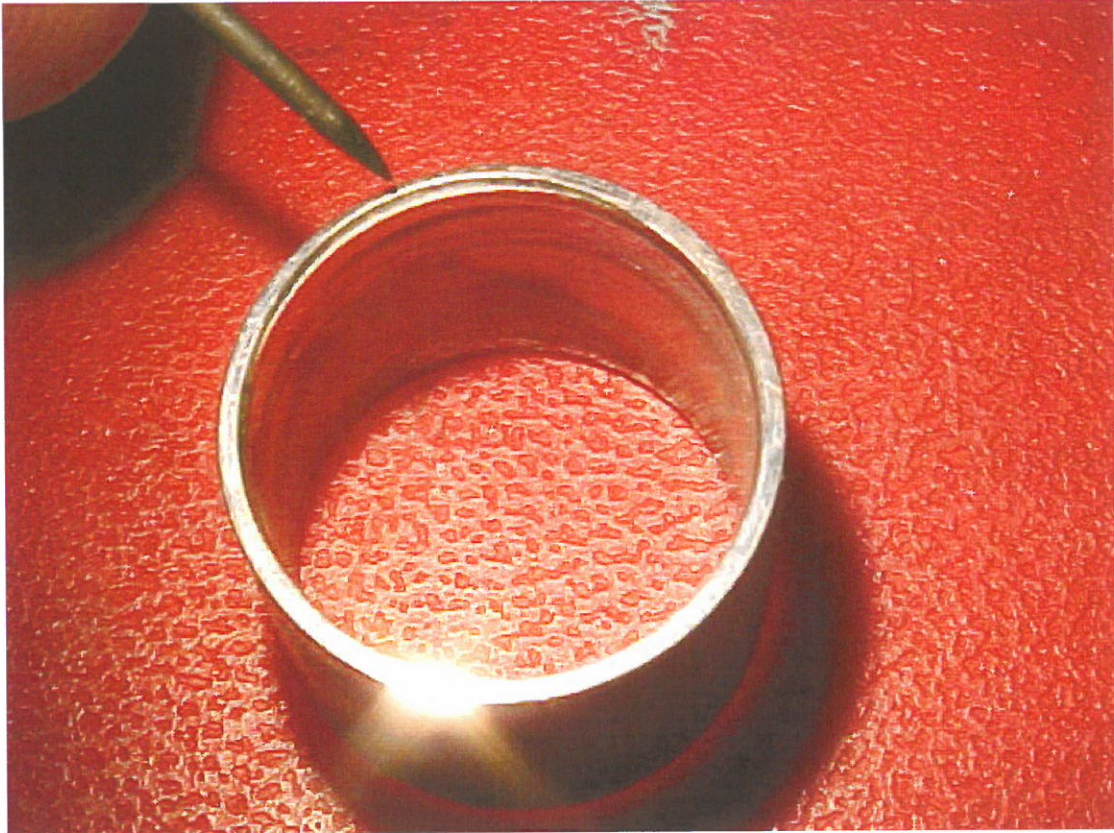
Figure 18

The telescoping filler tube sleeve was developed to help insure successful assembly of the high-pressure components. Nonetheless, our experience tells that even with this aid, the parts are sometimes assembled incorrectly. Evidence of misassembly can be seen by looking at the end of the filler tube. A coined imprint can be seen if the filler tube was once assembled where it pinched the inlet poppet. If damage/deformation is severe enough, motion of the poppet may be impaired. In this case it is possible to flip the part end for end and use the undamaged surface nearest the inlet poppet.

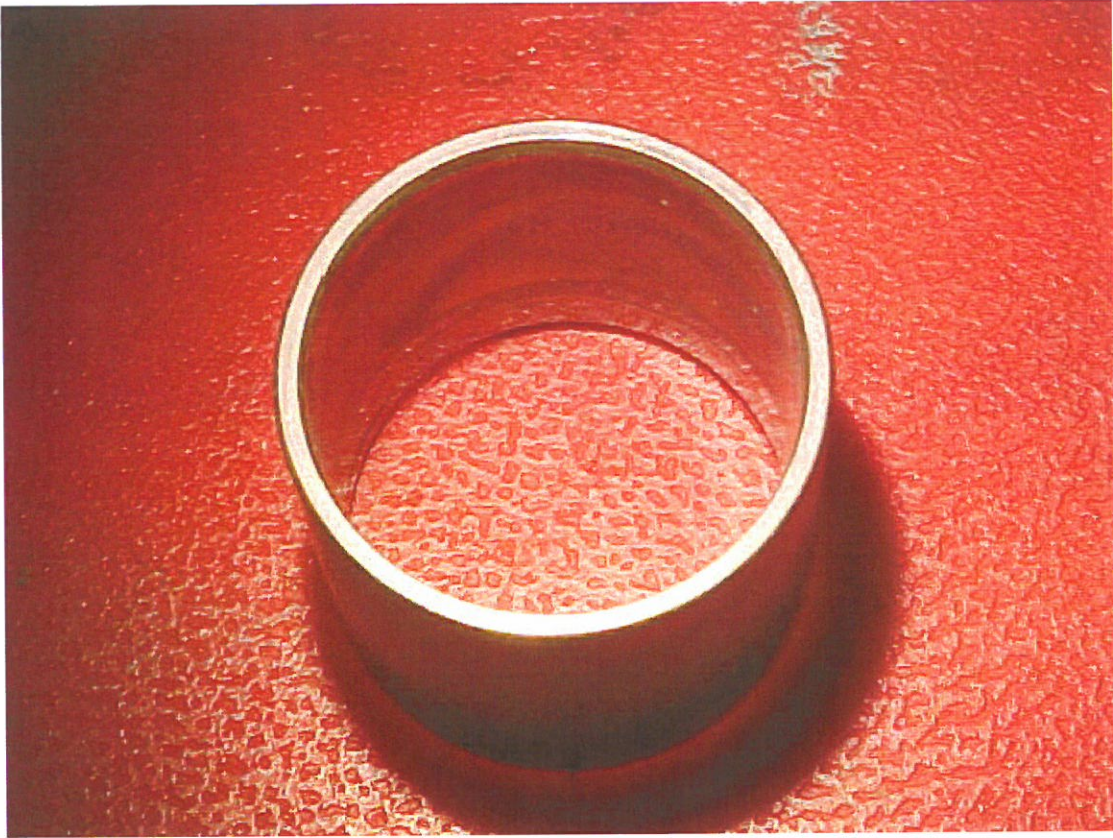
Figure 19

The second photo shows the typical look of an undamaged filler tube sleeve. A shiny end surface is typical and is caused by repeated contact between the filler tube and the checkvalve body. This reciprocating contact wears the sleeve and eventually shortens it to where it must be replaced. The sleeve length should be $.670 \pm .002$.

The sleeve is now part of the minor maintenance kit.

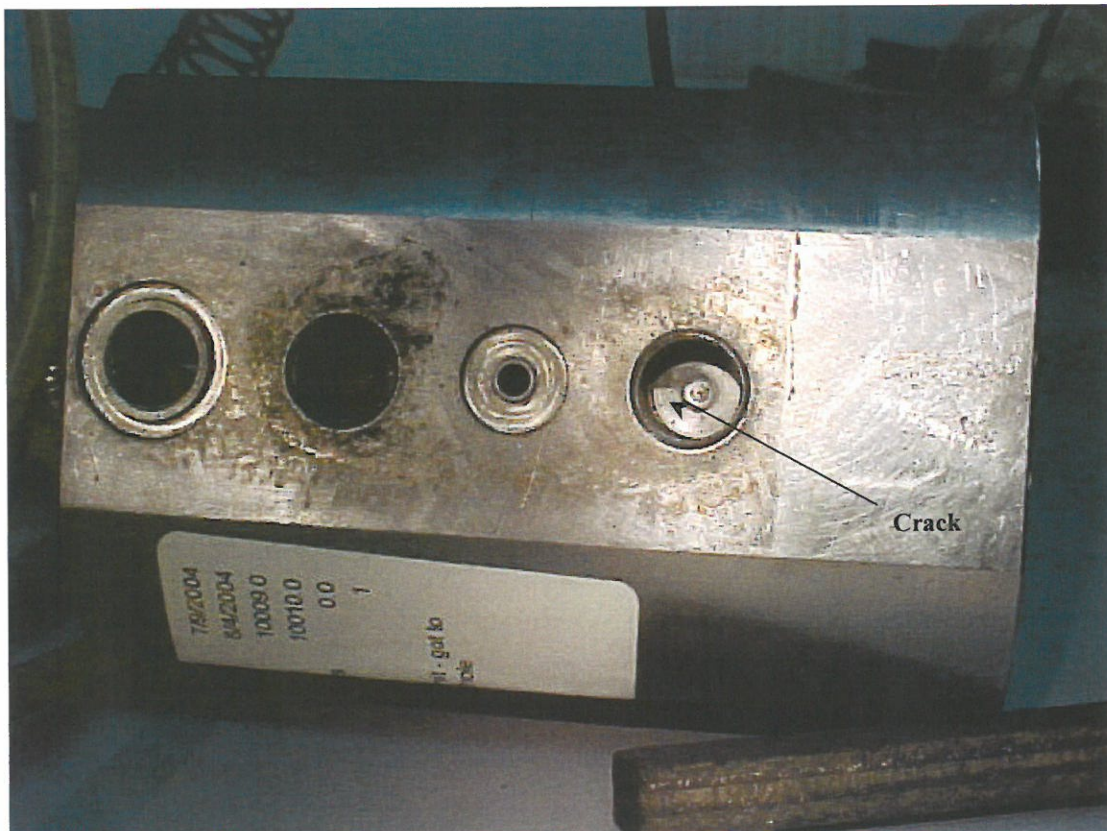
Figure 20

End caps ideally should not experience the pressure fluctuations great enough to result in fatigue failures. Our experience shows us that reality is not ideal and endcaps fail due to fatigue. Applications with many pump motor on/off cycles are the most likely to see endcap failures. Pressure pulse resonance problems may also be suspected. The endcap failure is identified by this classic characteristic: A crack originating from the endcap outlet hole at the inner diameter of the cap, propagates upward to intersect with the manifold bolt hole. The leakage that results is often mistaken for a failed manifold seal. Inspection of the bottom of the bolt hole will reveal a small crack as shown below.

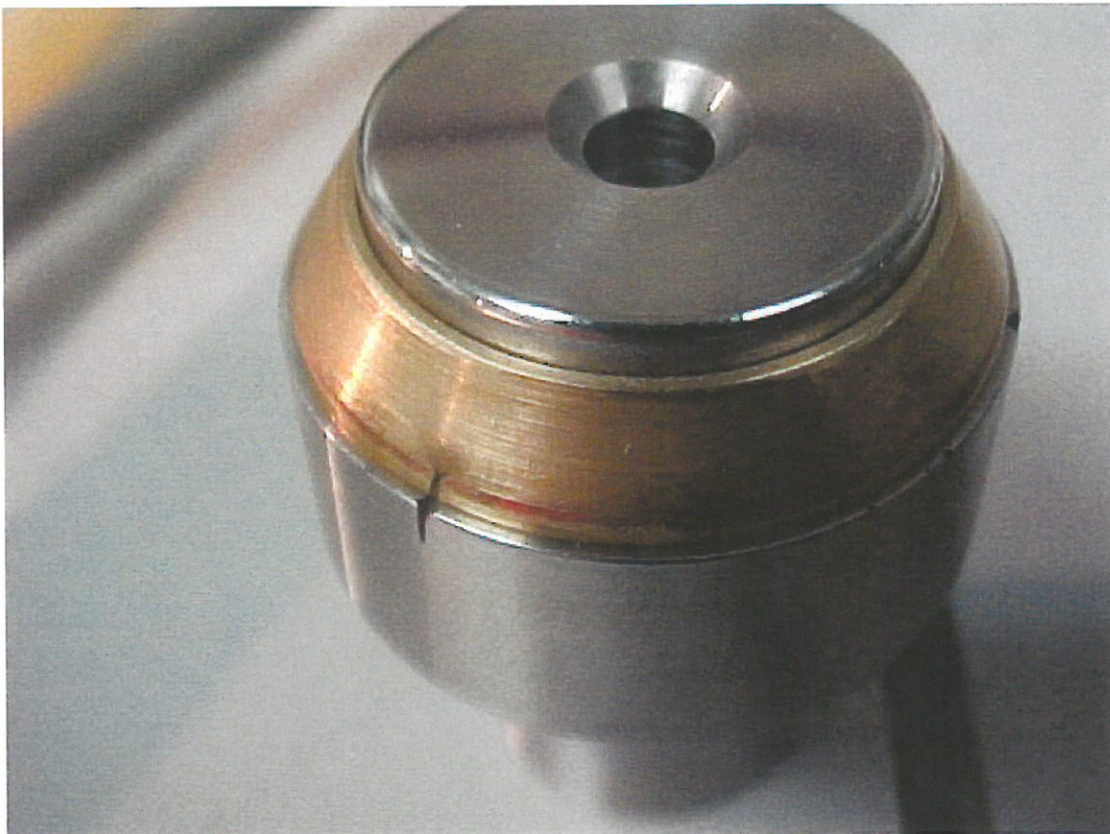
Figure 21

There are two bronze manifold seals, one at each end of the manifold. When a PCV is used (30 and 50hp units) then, the outlet end has an adapter with a large static seal. The PCV seat on the other end uses a smaller version of this seal. Our experience shows us that the large seal is a bit sensitive to leakage if the torque is not high enough. If a drip is evident at the weep hole, experienced operators will encourage the seal to stop leaking by applying a little more torque to the fitting. If the seal is allowed to leak, the seal (and possibly the manifold) will become eroded and the damage may be enough that the seal will never seal again. Troublesome seals should be inspected for erosion damage. The photo below shows a seal with minor erosion that should be replaced. The adapter, while damaged, does not need to be replaced.
