DP3000 INSTALLATION PROCEDURES FOR ORIFICE ASSEMBLY

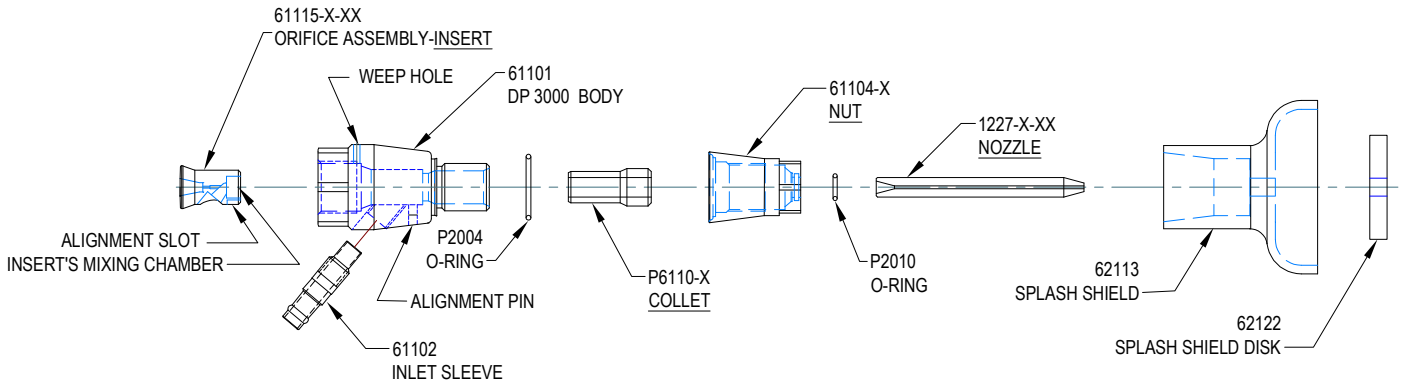
DIAGRAM of DP 3000

NOTE: ORIFICE ASSEMBLY-INSERT, NOZZLE, NUT, & COLLET ALL NEED TO MATCH

See diagram

- 1). Insert orifice assembly (insert) into DP 3000 body, being sure the slot matches to the pin inside the body. This is essential for proper alignment.
- 2). Apply “Blue Goop” to the threads of the extension tube and a small amount to the end of the extension tube where it seats against the orifice assembly (insert). The parts are all stainless steel and will gall together without the anti-seize compound.
- 3). Screw the DP 3000 body onto the extension tube. Tighten with wrench (~1/8” turn past hand tight corresponding to 55ft-lbs).

- 4). **Install the nozzle.** (Apply “Blue Goop” to the threads of the DP 3000 body prior to tightening the nut.)
Hold nozzle in place inside the insert while tightening the nut. A gap between the nozzle and the insert will cause the insert and/or nozzle to wear and/or fail prematurely. (Distance from nut to bottom of a 3” nozzle should = approximately 1.300”).
- 5). Apply “Blue Goop” to the threads of the inlet sleeve, only after the DP 3000 body has been secured to the extension tube. Screw inlet sleeve into the DP 3000 body using a wrench to lightly snug the inlet sleeve against the orifice assembly (insert).
